# Orange County Traffic Committee

**Item A**

**August 20, 2009**

# Request

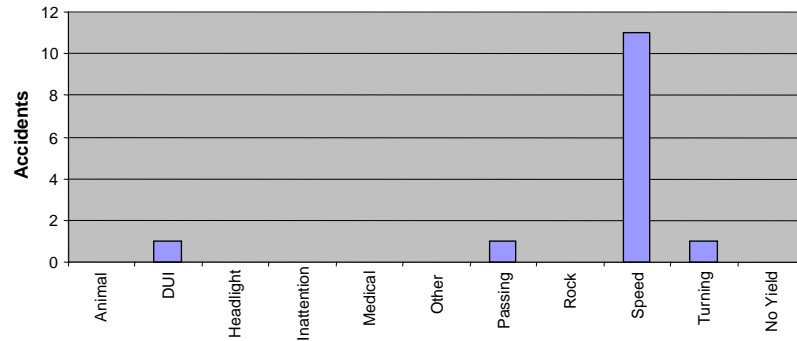
(Segment 1- Live Oak Canyon Road from El Toro Rd to Hamilton Trail)

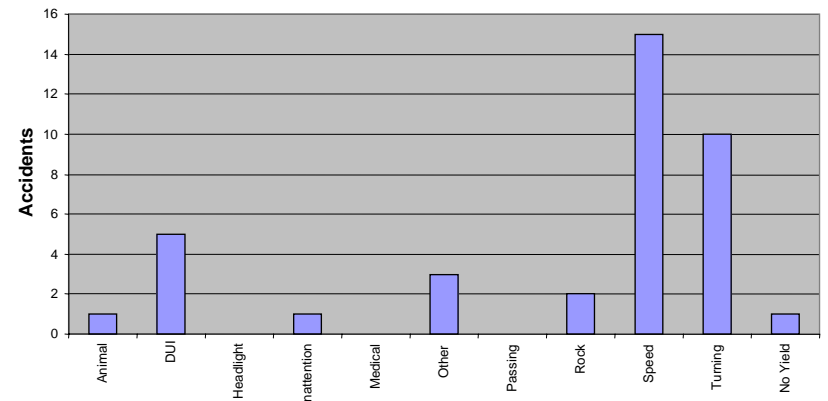
(Segment 3- Trabuco Canyon Rd from O'Neill Park to Plano Trabuco Rd)

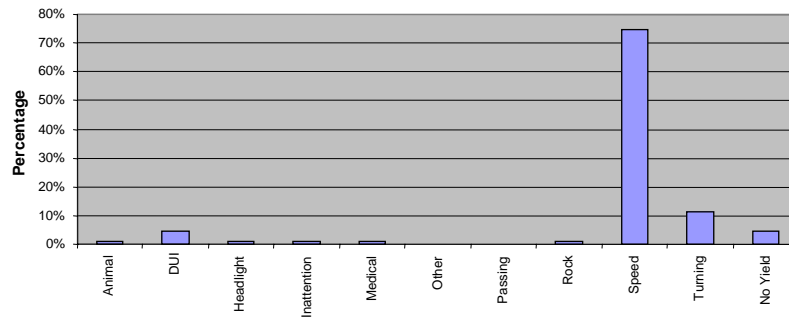
(Segment 2- Live Oak Canyon Rd from Hamilton Trail to O'Neill Park)

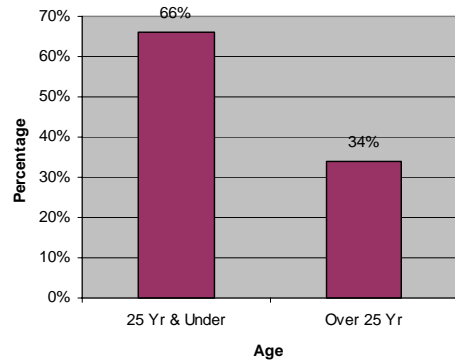
**Total Accidents by Age**

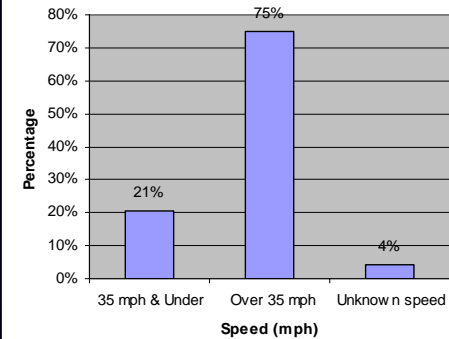
**Accidents by Drivers Age 25 and Under**

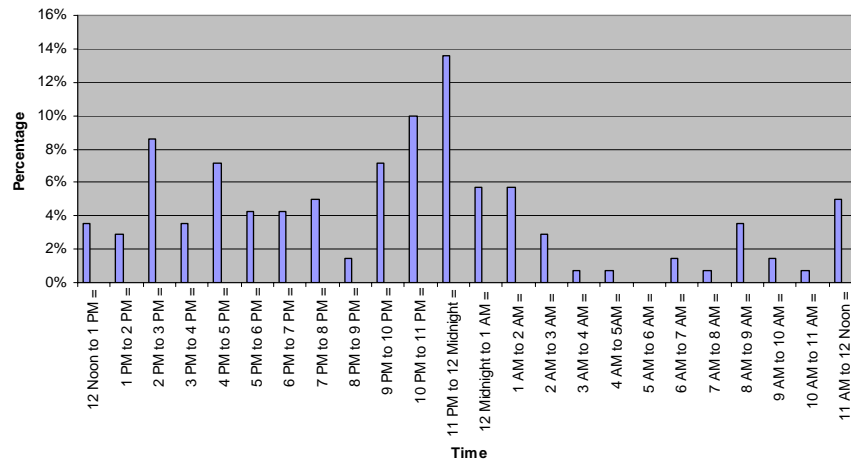
**Accidents by Time of Day**

- Most of these accidents were caused by young drivers and occurred during night hours, particularly between 9:00 pm and 2:00 am. The majority of these accidents may be caused by drivers either intentionally speeding or racing.

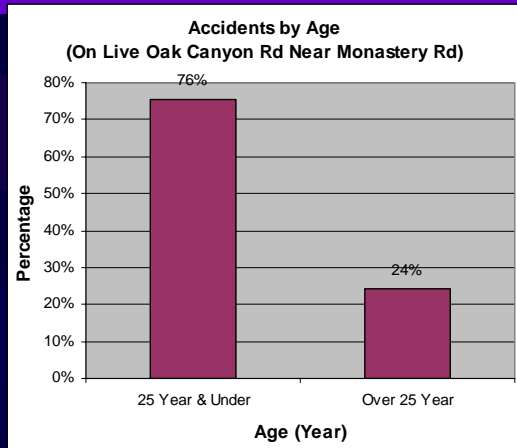
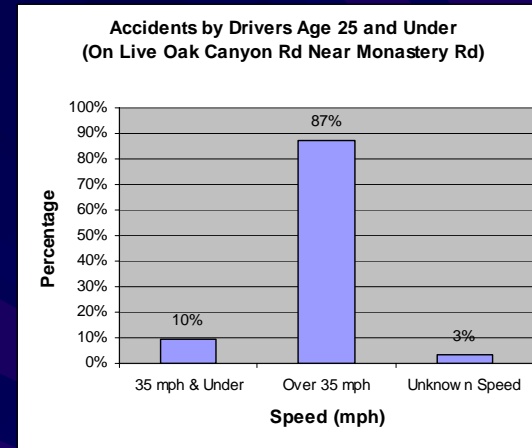
# Accident Concentration

- 90 accidents in three years between Hamilton Trail and O'Neill Park Entrance.
- 83% of accidents southbound.
- Accident concentration at curve near Monastery Rd.
- The primary cause of these accidents was vehicle speeds higher than 50 mph.

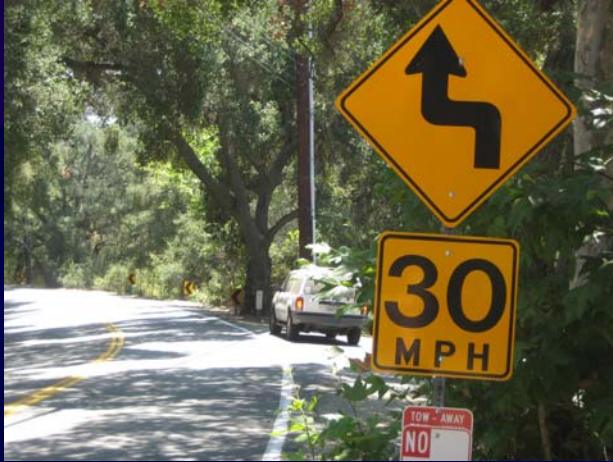
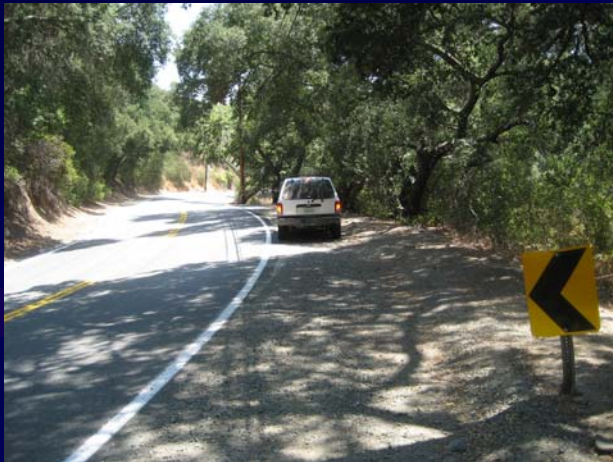
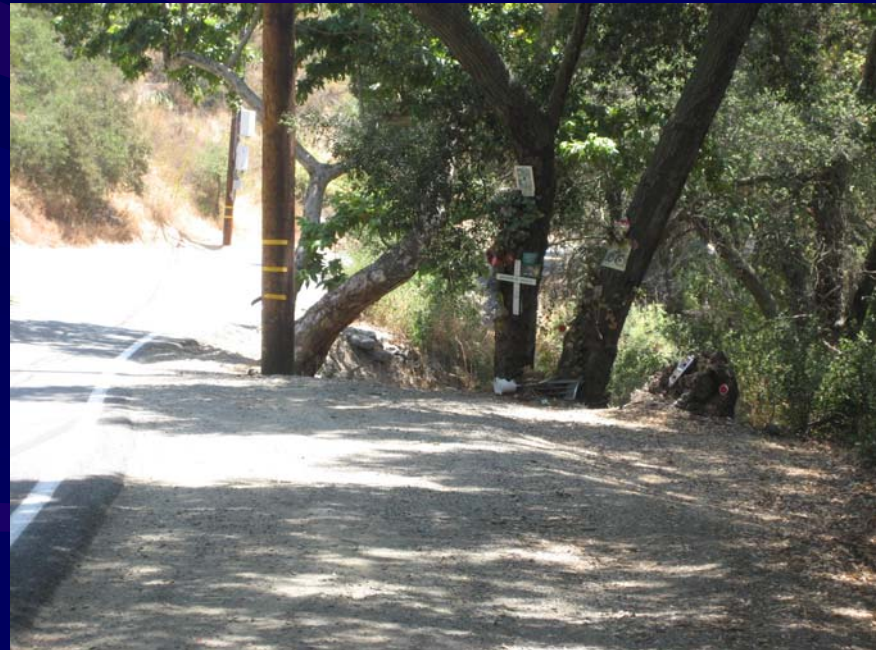
# Monastery Curve

- 4 of 7 Fatal accidents near Monastery Road

- Provide an animal warning sign (W11-3) for drivers entering the canyon from El Toro Road/Santiago Canyon Road.
- Install metal beam guardrail preceding the tree and utility pole at southbound Monastery curve.
